4036 – Whites Footbridge

SITE INSPECTION DETAILS

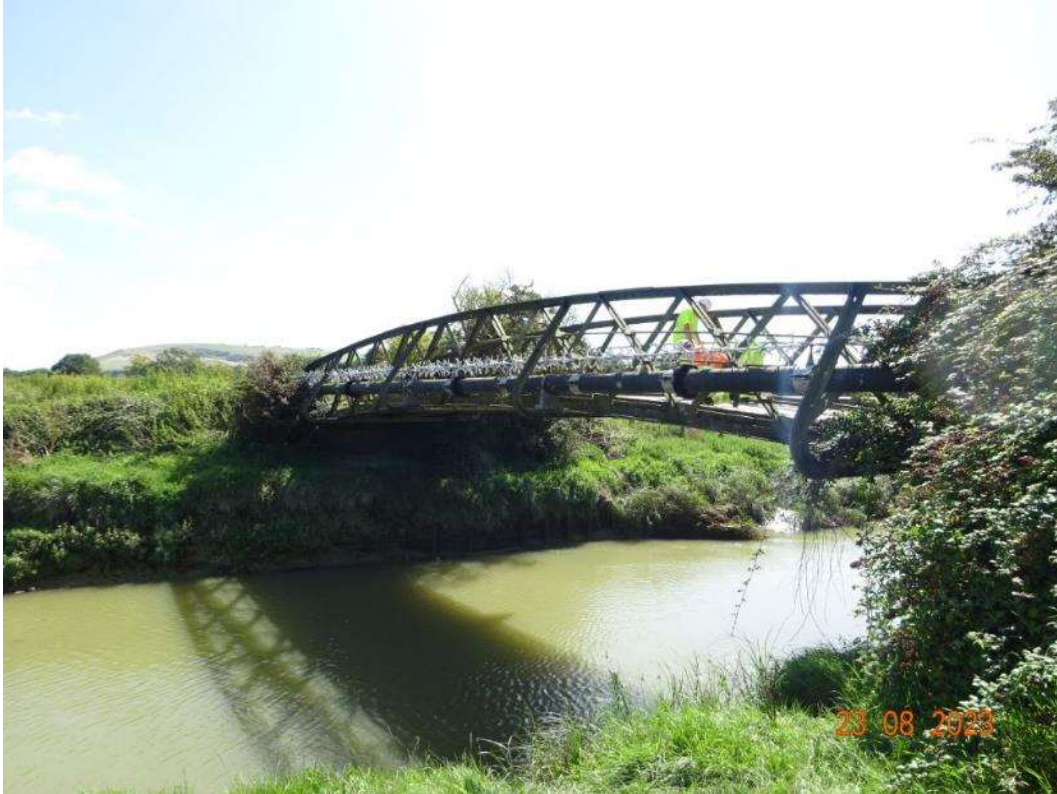
Figure 1: North Elevation

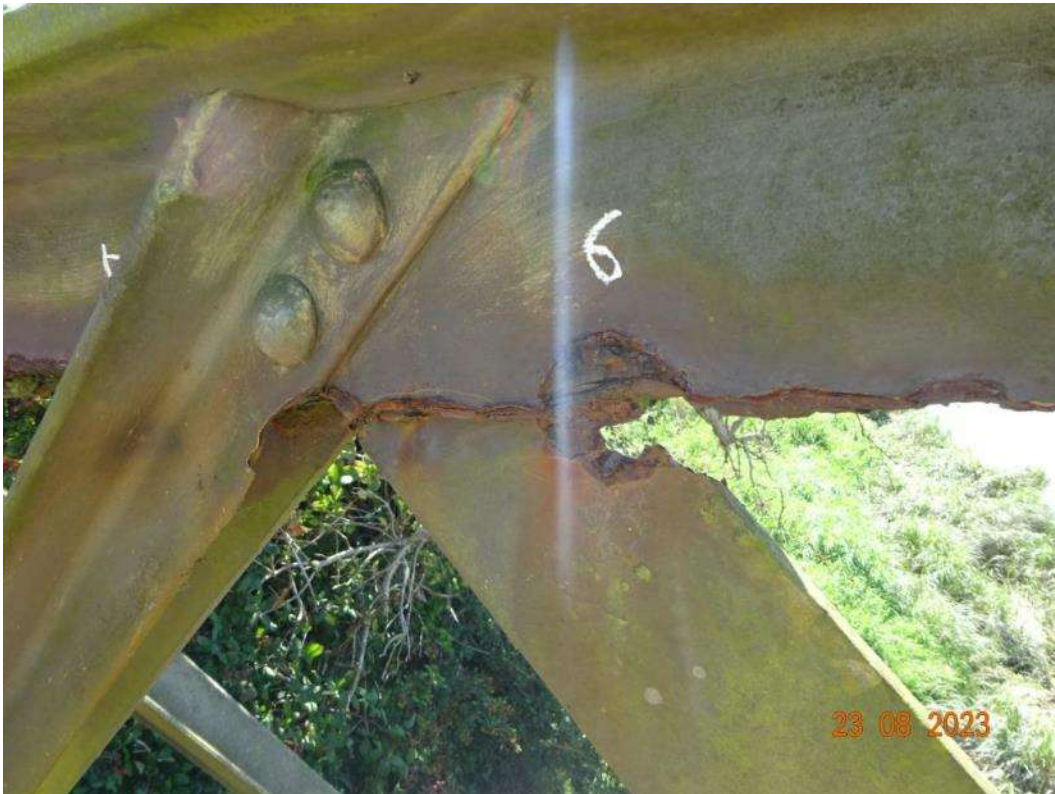
Figure 3: South Truss - View of disintegration corrosion to top chord and diagonal bracing (Defect 6)

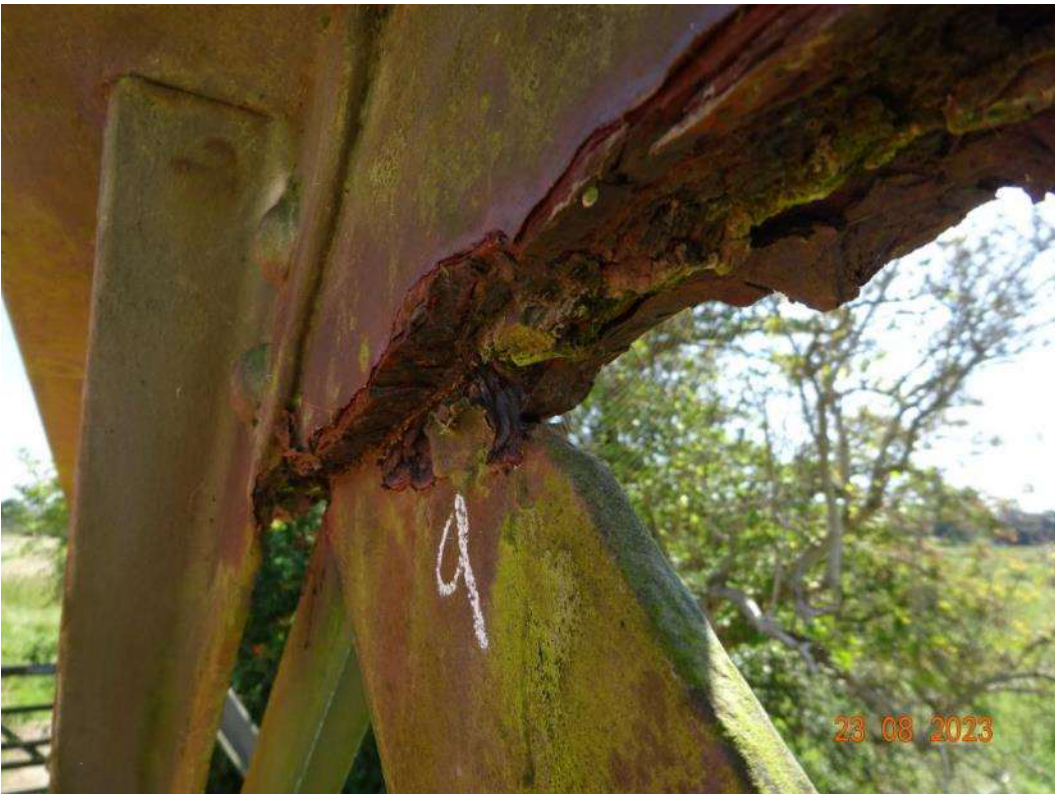
Figure 4: South Truss - View of consistent corrosion to top chord and diagonal bracing (Defect 9)

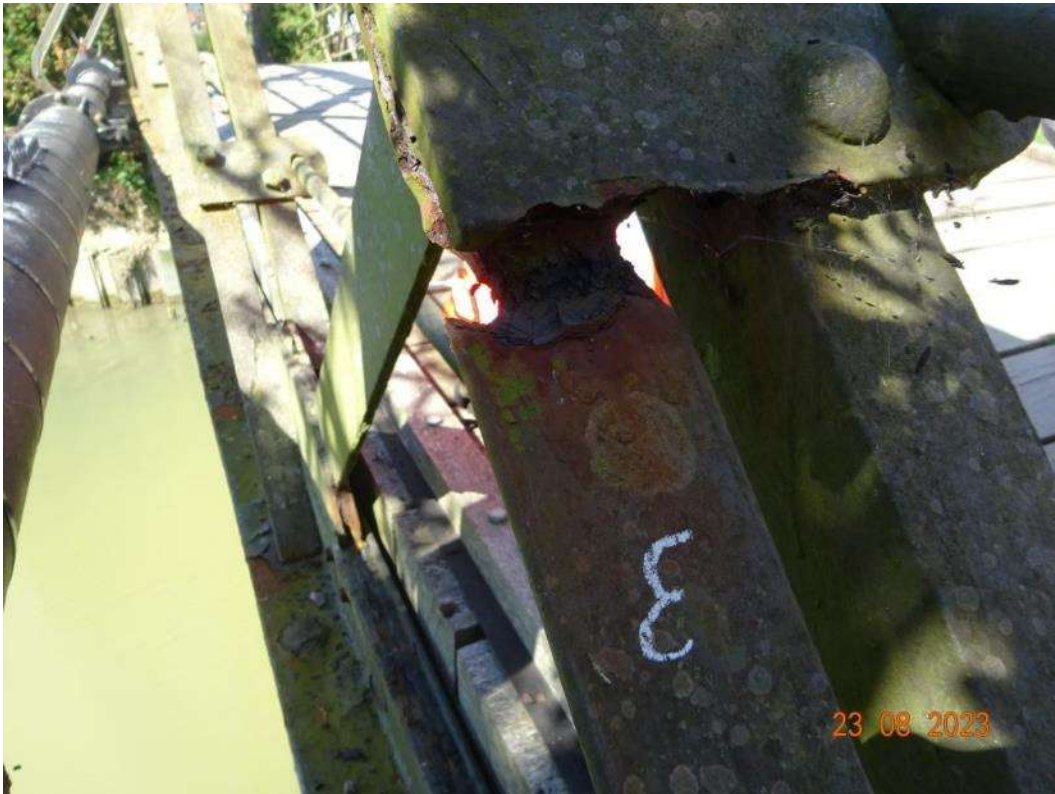
Figure 5: Disintegration of diagonal bracing (external plate, south)

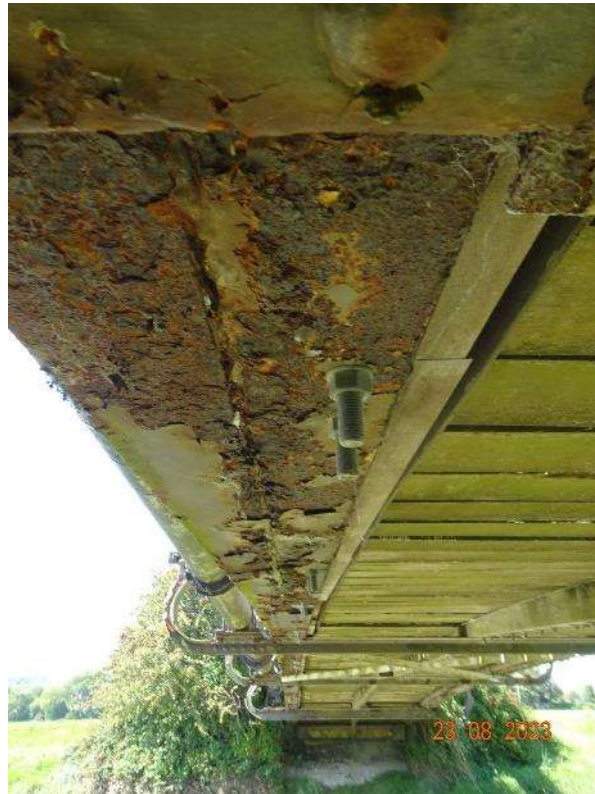
Figure 7: Severe pitting corrosion to bottom chord (south)

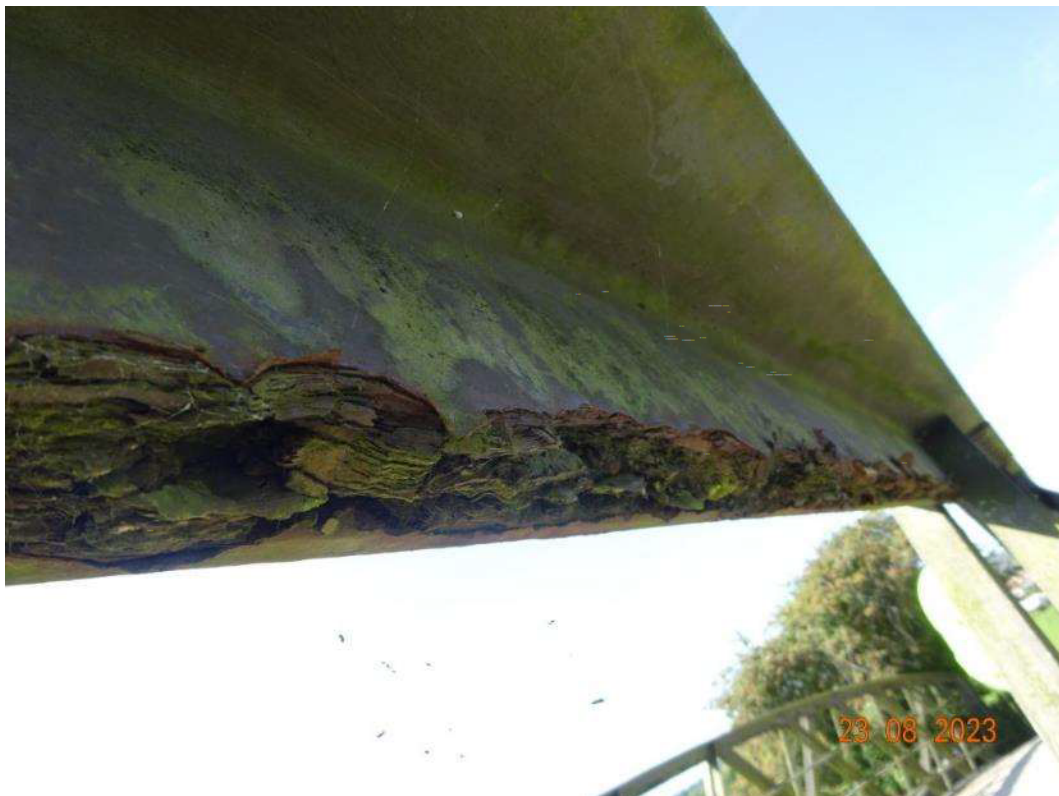
Figure 8: View of typical moder-major corrosion to underside of northern top chord

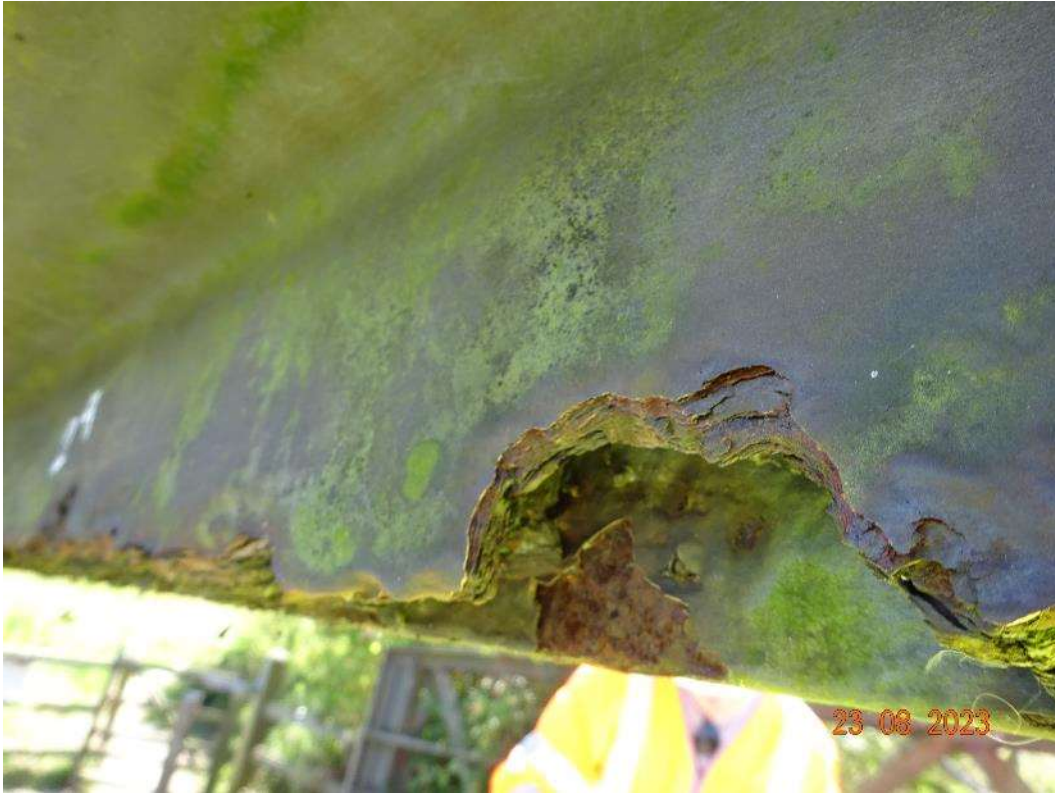
Figure 9: Major section loss to exterior member of top chord (north)

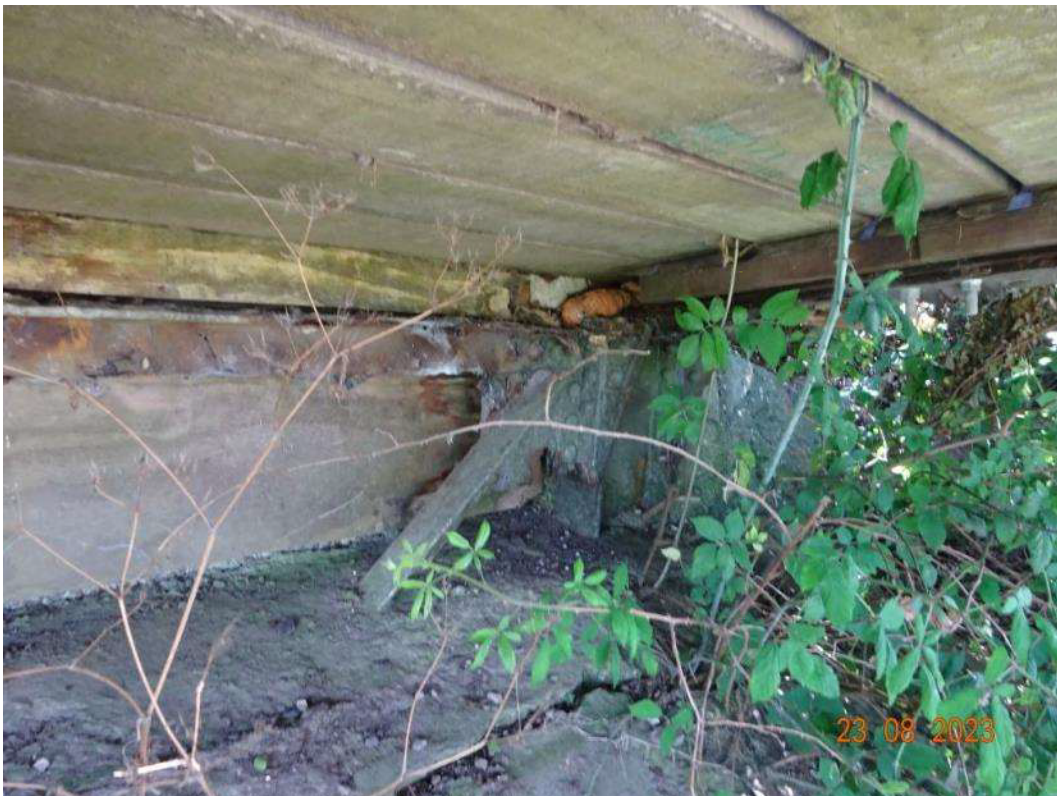
Figure 18: Transverse crack to concrete (east).

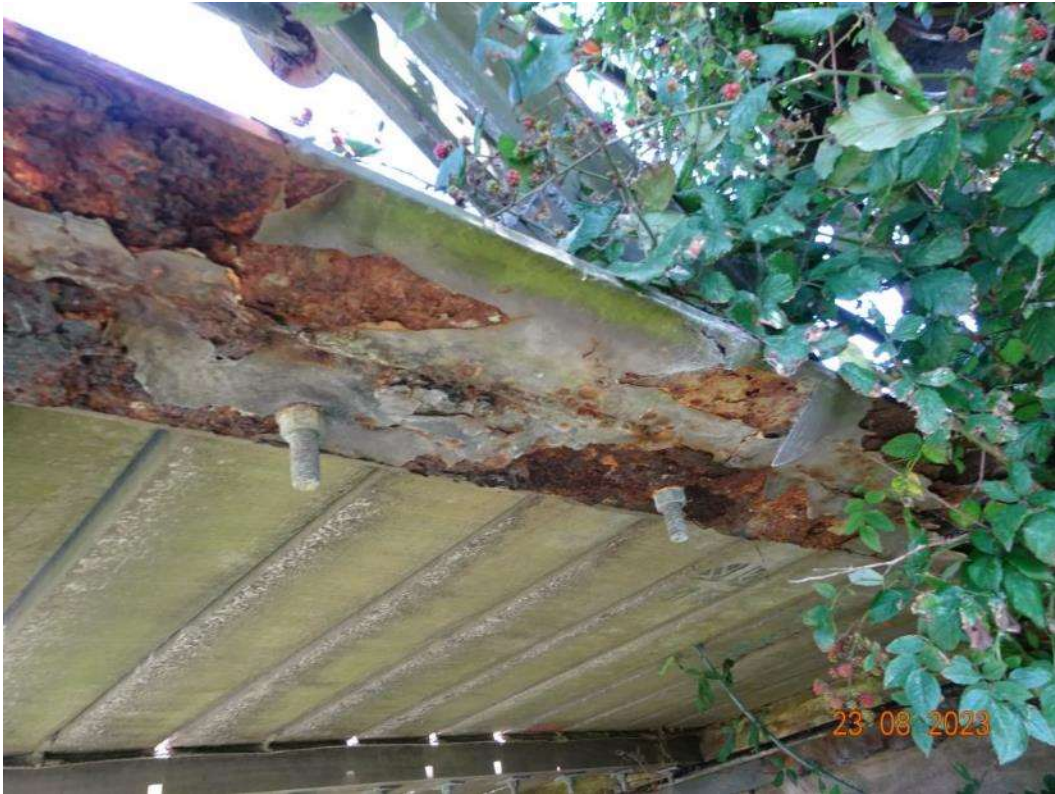
Figure 19: Significant paint loss allowing for corrosion to develop.

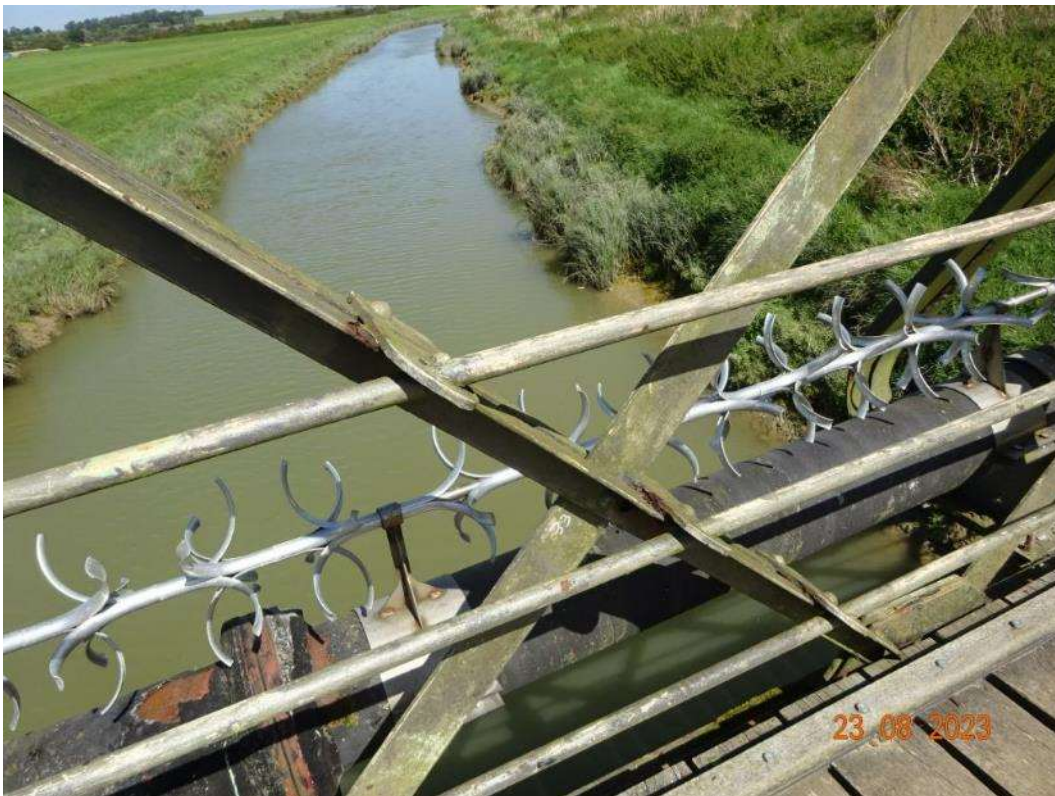
Figure 20: Slight paint losses to parapet railing.

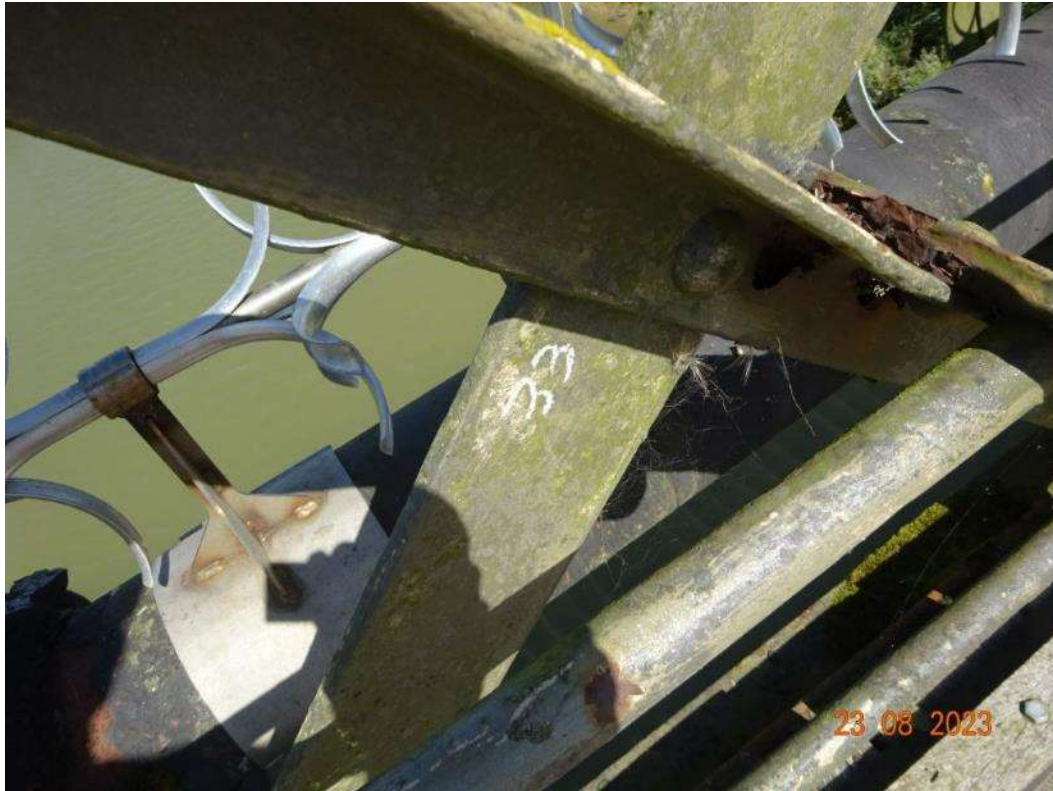
Figure 21: Minor surface corrosion to parapet railing.

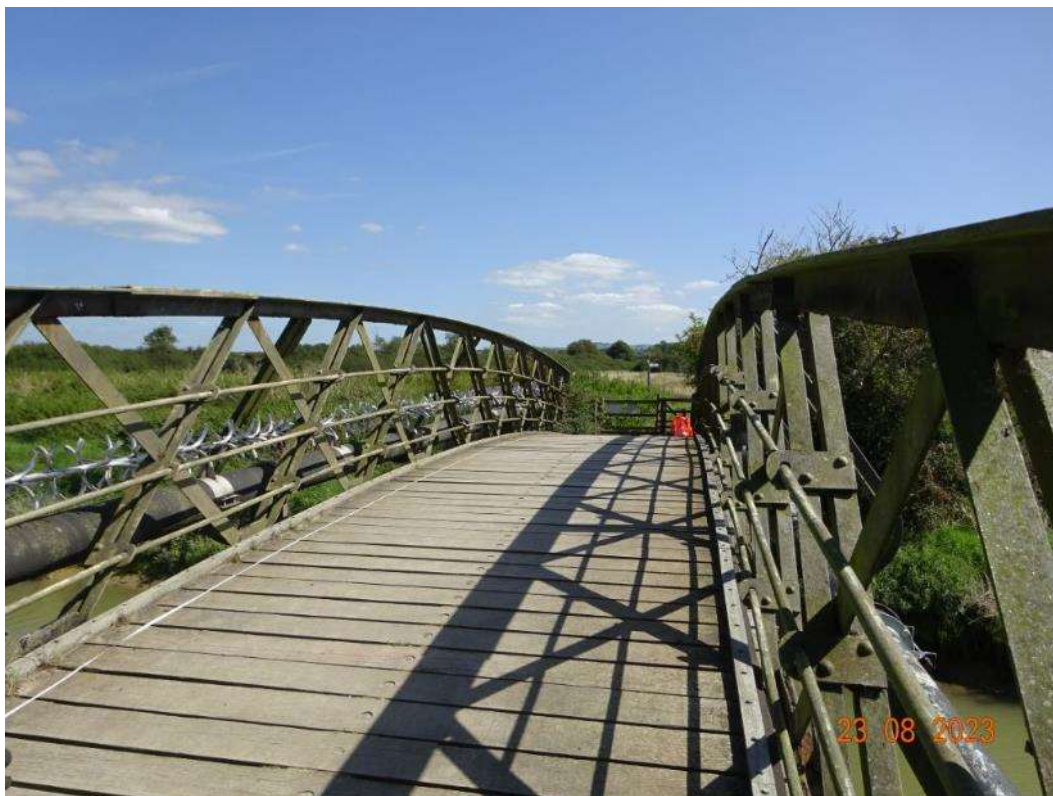
Figure 22: View looking east shows footway surfacing.

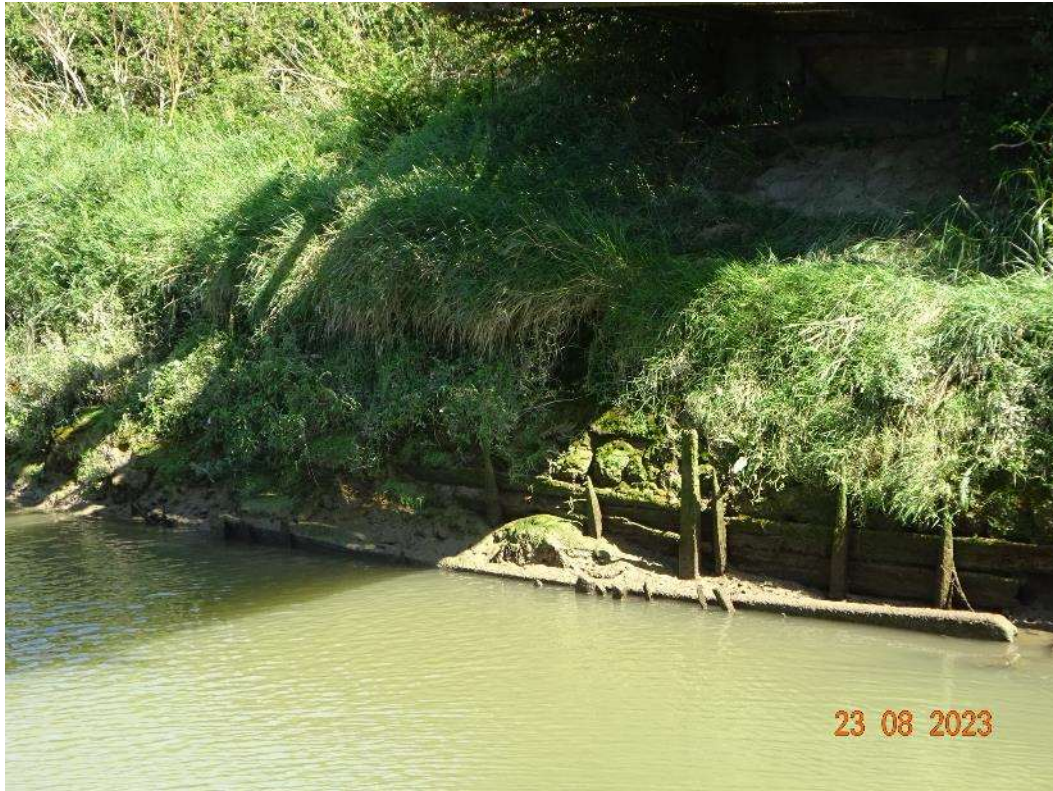
Figure 23: Deteriorated timber wall to east embankment.

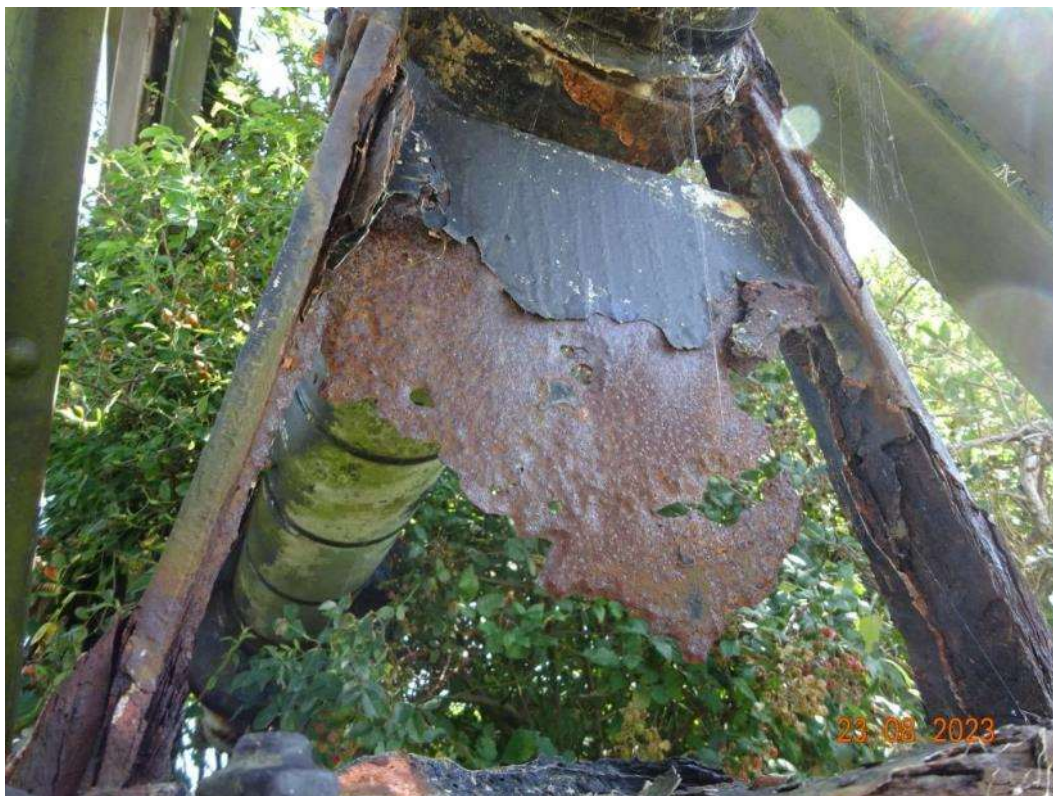
Figure 24: Disintegration of service pipe supports, pictured to south side.

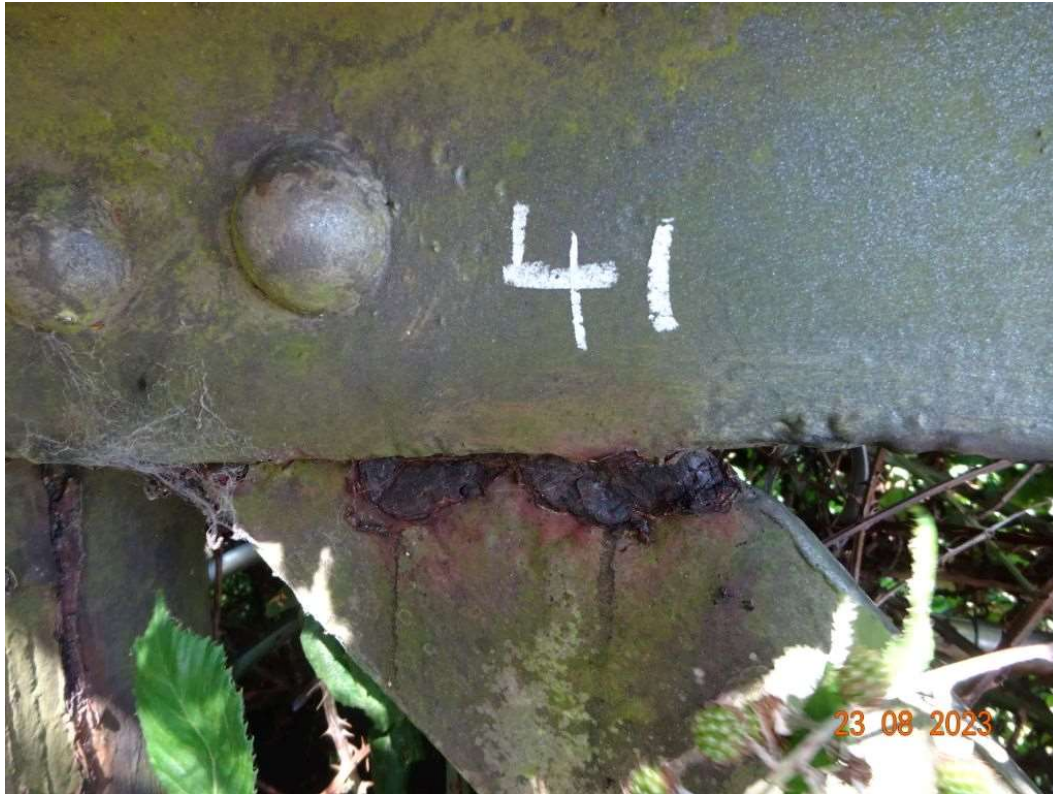
Figure 25: Typical example of corrosion found on the Northern truss. Diagonal bracing member (Defect 41)

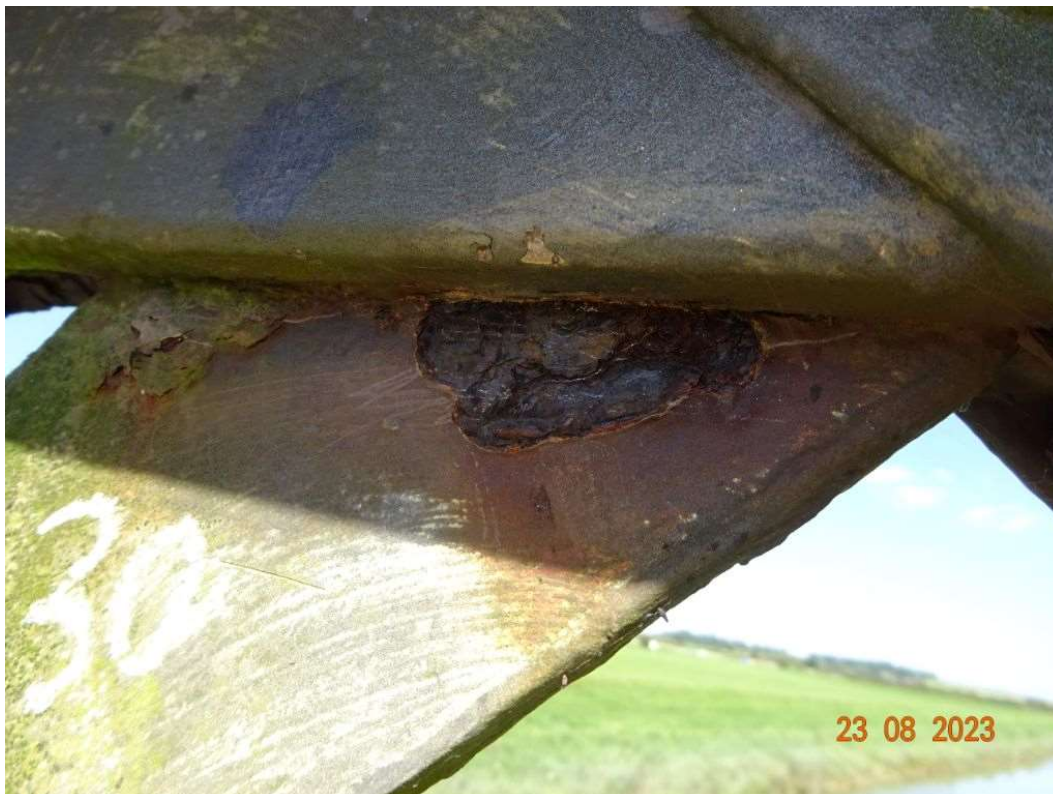
Figure 26: Significant pitted corrosion of diagonal bracing member – Northern truss (Defect 30)
